Study Purpose

Olsson Associates was tasked with performing multiple analyses at the intersection of 108th Street & Oak Street in Omaha, Nebraska. These included signal warrants, speed data analysis, crash data analysis, sight distance analysis, and a gap study. The purpose of the study was to determine if the existing traffic signal was justified at the intersection.

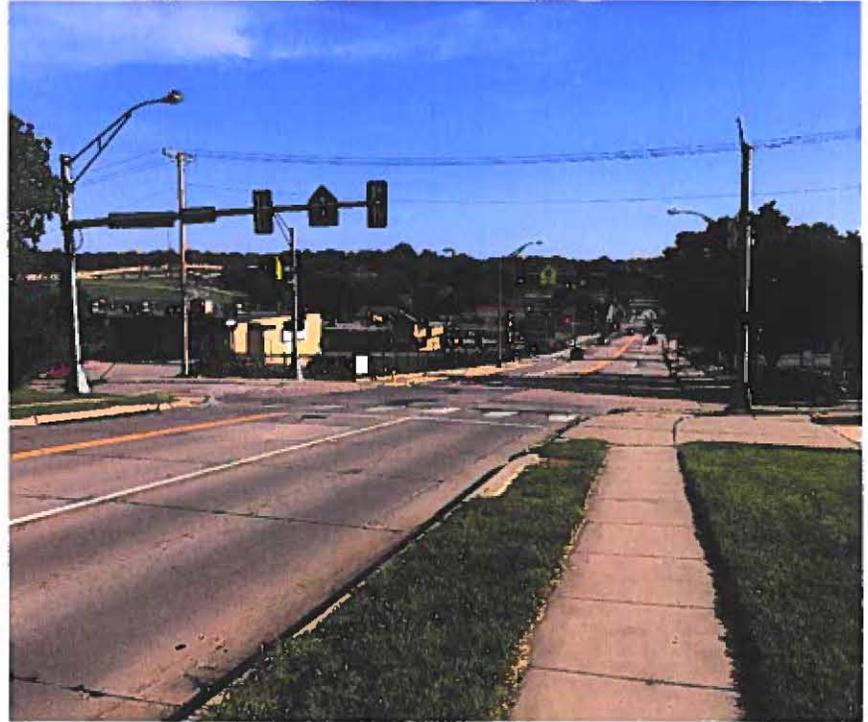
A view of the study intersection (looking north)

There are sight obstructions on the northeast and northwest corners of the intersection, but a vehicle could stop at the designated location and then edge forward when possible. Therefore, motorists have a clear view from Oak Street to enter the intersection.

- ✓ Remove the signal and convert the intersection to two-way stop control.
- ✓ Stakeholder Coordination:
 - Notification of removal
 - Discussion of other potential routes for children walking to school.
- ✓ Improve accessibility along alternate routes as needed.
- ✓ Where possible, remove obstructions to increase intersection sight distance.
